**Flood Control Project Maintenance
Levee Inspections**
LMA District Cover Sheet
Spring 2017 Levee Inspection Results

Levee District No. 0001 (Glenn County)

Spring 2017 Levee Inspection Results

Waterway			Bank	Unit Miles
Unit No. 01 Sacramento River			Right	12.23
	Spring (March - May)	Summer (June - August)	(September - November) Fall	Winter (December - February)
Unit Maintenance Rating (Fall Only)				
Date of Inspection	3/28/2017 - 3/28/2017			
DWR Inspector	Bob Duffey			
Accompanied By	Bill Carriere LD1G

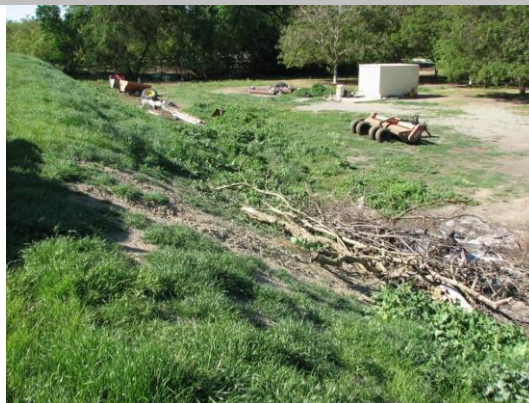
Photo 1 of 1 : SP_2017_LD0001G_432_73_20170315_00037.jpg

LM Start	0.02	Rating **	M	Issue No.	73
LM End	0.04	Issue Type +	En	Location *	LS
Category	Earthen Levee			GPS Latitude/Longitude	
				Start	End
Item	Encroachments			39.477372 °	39.477833 °
				-122.017602 °	-122.017484 °
DWR ID	DWR_LD0001G_01_s_2016_73				
Comment Code					
EQ : Equipment					
Inspector Comment					
Remove ag equipment at LS toe.

View of the prunings pile and ag equipment at the landside toe.

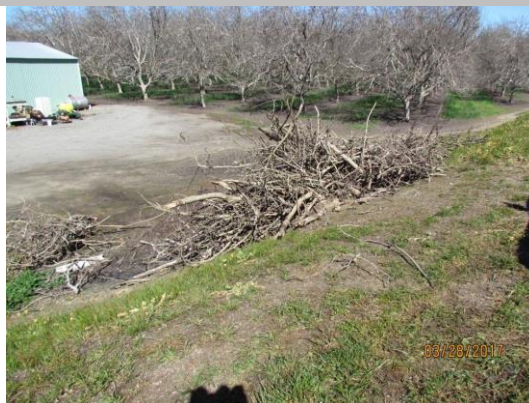
Photo 1 of 1 : SP_2017_LD0001G_432_40_20170330_00121.jpg

LM Start	0.05	Rating **	M	Issue No.	40
LM End	0.05	Issue Type +	En	Location *	LS
Category	Earthen Levee			GPS Latitude/Longitude	
				Start	End
Item	Encroachments			39.477833 °	39.477833 °
				-122.017484 °	-122.017484 °
DWR ID	DWR_LD0001G_01_s_2016_40				
Comment Code					
PR : Prunings					
Inspector Comment					
Remove prunings at LS toe.

View of the prunings along the landside slope and toe.

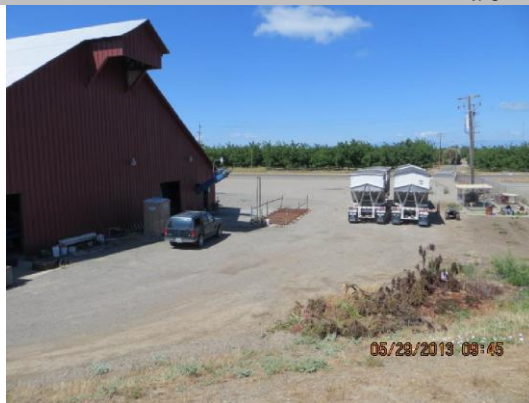
Photo 2 of 3 : UCIP_SP_2017_14324_23563.jpg

LM Start	0.77	Rating **	M	Issue No.	396 (cont)
LM End	0.77	Issue Type +	En	Location *	WS

Concrete sump next to barn off LS toe.

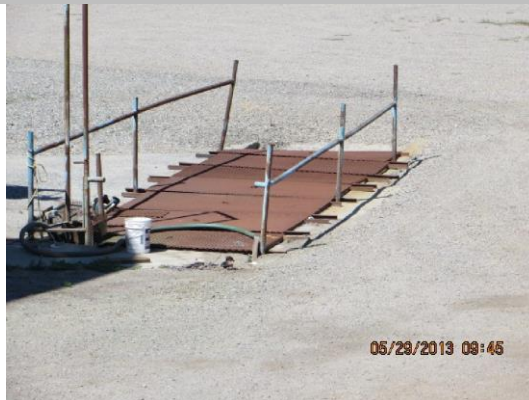
Photo 3 of 3 : UCIP_SP_2017_14324_23562.jpg

Concrete sump next to barn off LS toe.

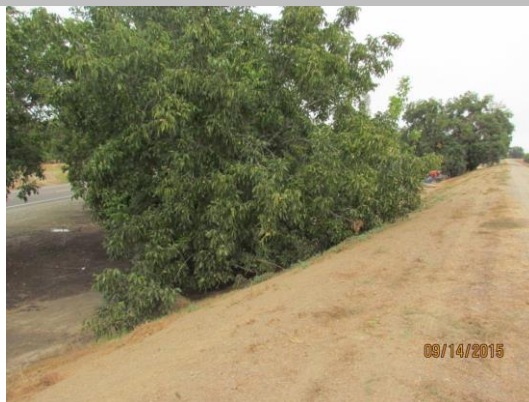
Photo 1 of 1 : SP_2017_LD0001G_432_43_20170315_00012.jpg

LM Start	1.01	Rating **	M	Issue No.	43
LM End	1.01	Issue Type +	Ma	Location *	WS
Category	Earthen Levee			GPS Latitude/Longitude	
				Start	End
Item	Trim / Thin Trees			39.490963 °	39.490963 °
				-122.020510 °	-122.020510 °
DWR ID	DWR_LD0001G_01_f_2016_43				
Comment Code					
T1 : Trim trees to at least five feet above ground level.					
Inspector Comment

View of the tree limbs on the landside slope.

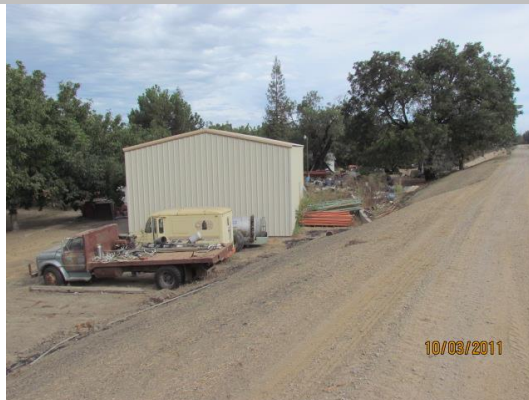
Photo 1 of 1 : SP_2017_LD0001G_432_74_20170315_00038.jpg

LM Start	1.09	Rating **	M	Issue No.	74
LM End	1.17	Issue Type +	En	Location *	LS
Category	Earthen Levee			GPS Latitude/Longitude	
				Start	End
Item	Encroachments			39.492090 °	39.492090 °
				-122.020014 °	-122.020014 °
DWR ID	DWR_LD0001G_01_s_2016_74				
Comment Code					
AV : Abandoned vehicles					
Inspector Comment					
Abandoned vehicles and equipment at LS toe.

View of vehicles & equipment along the L/S toe.

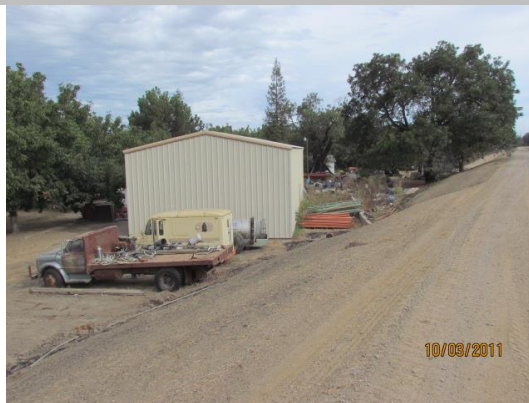
Photo 1 of 1 : SP_2017_LD0001G_432_4_20170315_00001.jpg

LM Start	1.11	Rating **	M	Issue No.	4
LM End	1.11	Issue Type +	En	Location *	LS
Category	Earthen Levee			GPS Latitude/Longitude	
				Start	End
Item	Encroachments			39.491887 °	39.494572 °
				-122.020238 °	-122.017840 °
DWR ID	DWR_LD0001G_01_s_2012_4				
Comment Code					
BU : Building					
Inspector Comment

View of unpermitted building L/S toe.

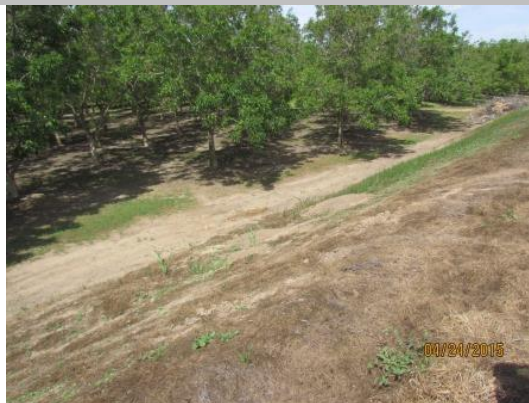
Photo 1 of 2 : SP_2017_LD0001G_432_59_20170315_00025.jpg

LM Start	1.22	Rating **	M	Issue No.	59
LM End	1.22	Issue Type +	Ma	Location *	LS
Category	Earthen Levee			GPS Latitude/Longitude	
				Start	End
Item	Animal Control			39.493667 °	39.493667 °
				-122.018643 °	-122.018643 °
DWR ID	DWR_LD0001G_01_f_2015_59				
Comment Code					
A3 : No rodents visible, but rodent burrows visible; need to backfill and compact or grout burrows.					
Inspector Comment					
The levee district has a rodent program in place.

View of the rodent holes along the landside slope.

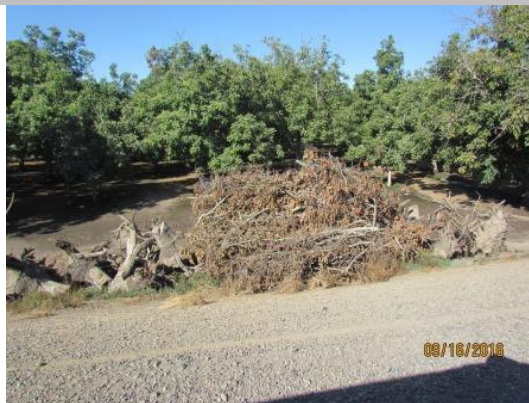
Photo 2 of 2 : SP_2017_LD0001G_432_61_20170315_00028.jpg

LM Start	2.48	Rating **	M	Issue No.	61 (cont)	
LM End	2.48	Issue Type +	En	Location *	LS	
Category	Earthen Levee			GPS Latitude/Longitude		
				Start		End
Item	Encroachments			39.505237 °		39.505237 °
				-122.006493 °		-122.006493 °
DWR ID	DWR_LD0001G_01_s_2015_61					
Comment Code						
PR : Prunings						
Inspector Comment						
Remove prunings from the LS toe.

View of the prunings along the landside toe.

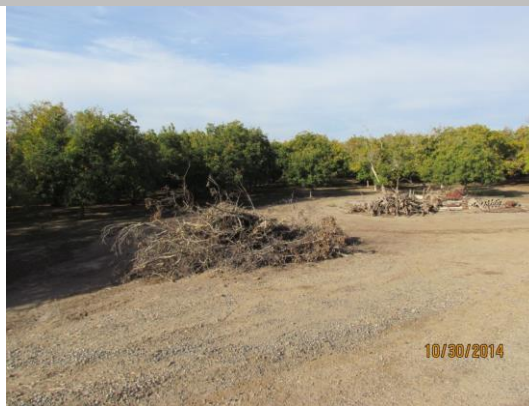
Photo 1 of 1 : SP_2017_LD0001G_432_49_20170315_00016.jpg

LM Start	2.80	Rating **	M	Issue No.	49
LM End	2.80	Issue Type +	En	Location *	LS
Category	Earthen Levee			GPS Latitude/Longitude	
				Start	End
Item	Encroachments			39.509503 °	39.509503 °
				-122.008732 °	-122.008732 °
DWR ID	DWR_LD0001G_01_f_2014_49				
Comment Code					
PR : Prunings					
Inspector Comment

View of the prunings along the landsides toe.

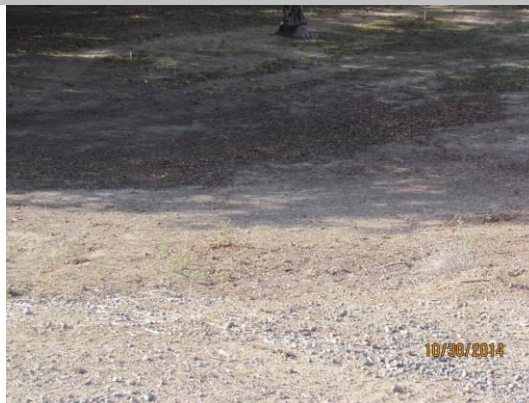
Photo 1 of 1 : SP_2017_LD0001G_432_50_20170315_00017.jpg

LM Start	2.80	Rating **	M	Issue No.	50
LM End	2.80	Issue Type +	Ma	Location *	LS
Category	Earthen Levee			GPS Latitude/Longitude	
				Start	End
Item	Animal Control			39.509503 °	39.509503 °
				-122.008732 °	-122.008732 °
DWR ID	DWR_LD0001G_01_f_2014_50				
Comment Code					
A3 : No rodents visible, but rodent burrows visible; need to backfill and compact or grout burrows.					
Inspector Comment

View of the rodent activity along the landside slope.

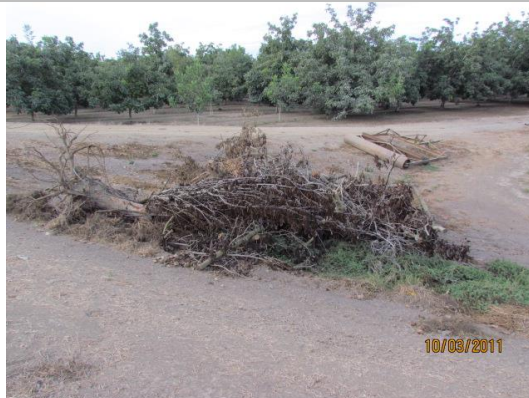
Photo 1 of 1 : SP_2017_LD0001G_432_16_20170315_00007.jpg

LM Start	3.19	Rating **	M	Issue No.	16
LM End	3.19	Issue Type +	En	Location *	LS
Category	Earthen Levee			GPS Latitude/Longitude	
				Start	End
Item	Encroachments			39.514709 °	39.514709 °
				-122.010515 °	-122.010515 °
DWR ID	DWR_LD0001G_01_s_2012_16				
Comment Code					
PR : Prunings					
Inspector Comment

View of the pruning pile along the L/S toe.

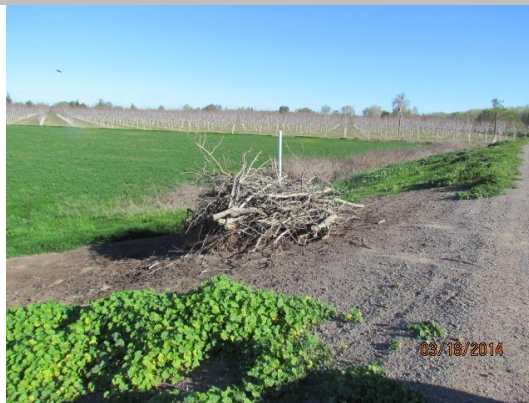
Photo 1 of 1 : SP_2017_LD0001G_432_46_20170315_00013.jpg

LM Start	3.39	Rating **	M	Issue No.	46
LM End	3.39	Issue Type +	En	Location *	LS
Category	Earthen Levee			GPS Latitude/Longitude	
				Start	End
Item	Encroachments			39.517389 °	39.517389 °
				-122.010685 °	-122.010685 °
DWR ID	DWR_LD0001G_01_s_2016_46				
Comment Code					
PR : Prunings					
Inspector Comment

View of the prunings along the landside slope.

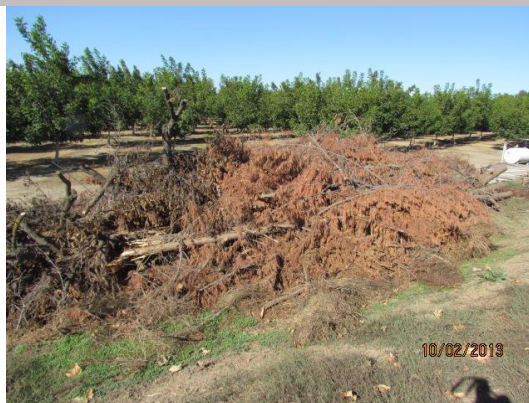
Photo 1 of 1 : SP_2017_LD0001G_432_56_20170315_00022.jpg

LM Start	3.63	Rating **	M	Issue No.	56
LM End	3.63	Issue Type +	En	Location *	LS
Category	Earthen Levee			GPS Latitude/Longitude	
				Start	End
Item	Encroachments			39.520623 °	39.520623 °
				-122.010457 °	-122.010457 °
DWR ID	DWR_LD0001G_01_f_2013_56				
Comment Code					
PR : Prunings					
Inspector Comment

View of the prunings and limbs along the slope of the levee.

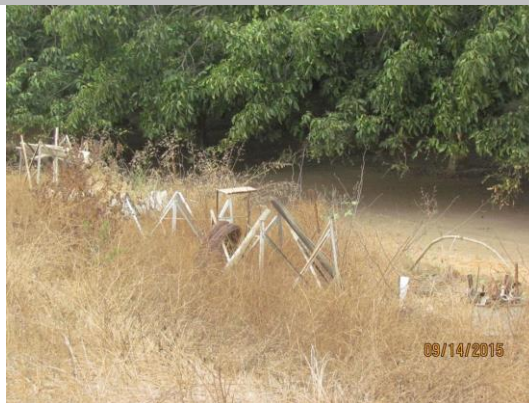
Photo 1 of 1 : SP_2017_LD0001G_432_23_20170315_00009.jpg

LM Start	3.86	Rating **	M	Issue No.	23
LM End	3.86	Issue Type +	En	Location *	LS
Category	Earthen Levee			GPS Latitude/Longitude	
				Start	End
Item	Encroachments			39.523660 °	39.523660 °
				-122.010863 °	-122.010863 °
DWR ID	DWR_LD0001G_01_s_2012_23				
Comment Code					
EQ : Equipment					
Inspector Comment					
Remove equipment from the LS toe.

View of the equipment along the landside toe.

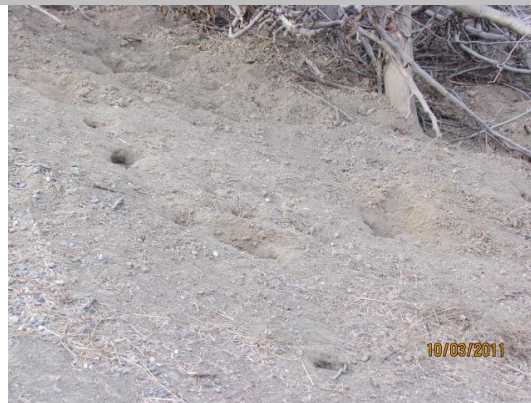
Photo 1 of 1 : SP_2017_LD0001G_432_395_20170315_00044.jpg

LM Start	3.88	Rating **	A/W	Issue No.	395
LM End	3.88	Issue Type +	Ma	Location *	LS
Category	Earthen Levee			GPS Latitude/Longitude	
				Start	End
Item	Animal Control			39.523845 °	39.523845 °
				-122.010745 °	-122.010745 °
DWR ID	DWR_LD0001G_01_s_2012_395				
Comment Code					
A3 : No rodents visible, but rodent burrows visible; need to backfill and compact or grout burrows.					
Inspector Comment					
Unable to see the rodent holes because of the prunings pile. Backfill and compact the rodent holes on the landside slope.

View of the rodent holes along the L/S toe.

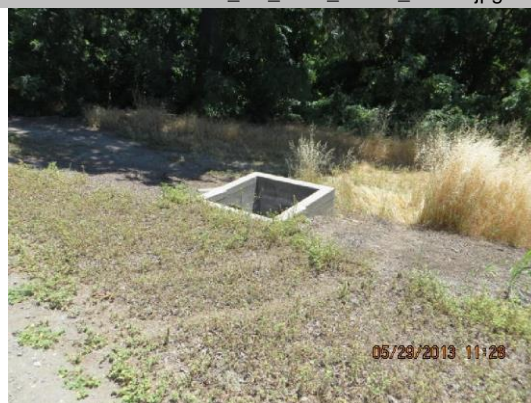
Photo 1 of 3 : UCIP_SP_2017_51463_27386.jpg

Comment Code					
Inspector Comment					
FS_ID:51463 DS_ID:22904 EP_NO: 9572 Repair Type: Urgent Crossing Status: Found UCIP Comments: 12/21/2016 Flap gate on WS does not appear to be broken however, flap gate does not fully close due to a 3-inch aluminum pipe sleeve through larger pipe. Need to remove 3-inch pipe in order to have WS flap gate close and to be compliant with Title 23. (O. Magana - DWR UCIP)05/29/2013 Broken flap gate and Concrete headwall on LS toe possibly tilting. Also a 3-inch alluminum irrigation line through the pipe. (W. Wylie - DWR UCIP) FIELD_STRUCT_DESC: 18-inch steel drainage pipe through levee, 7.3 feet below crown. Flap gate in 6-inch by 6-inch concrete box located on the waterside (WS) end. Concrete headwall located on the landside (LS) toe. (18-inch pipe authorized under Automatic Board Order (ABO) issued as Permit No. 9572, 1974 - H. & A. Smith). [Additional Reference(s): DWR Levee Log, 1992. USACE Sacramento O&M Manual Unit 140, May 1960, (HLM 4.05)]. FS Date: 12/21/2016

Distribution box on WS toe.

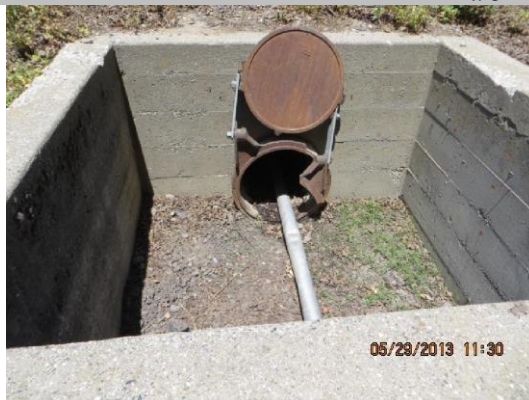
Photo 3 of 3 : UCIP_SP_2017_51463_27384.jpg

Item	DWR UCIP LMA Responsibility			39.524990 °		39.524990 °
				-122.009575 °		-122.009575 °
DWR ID						
Comment Code						
Inspector Comment						
FS_ID:51463 DS_ID:22904 EP_NO: 9572 Repair Type: Urgent Crossing Status: Found UCIP Comments: 12/21/2016 Flap gate on WS does not appear to be broken however, flap gate does not fully close due to a 3-inch aluminum pipe sleeve through larger pipe. Need to remove 3-inch pipe in order to have WS flap gate close and to be compliant with Title 23. (O. Magana - DWR UCIP)05/29/2013 Broken flap gate and Concrete headwall on LS toe possibly tilting. Also a 3-inch alluminum irrigation line through the pipe. (W. Wylie - DWR UCIP) FIELD_STRUCT_DESC: 18-inch steel drainage pipe through levee, 7.3 feet below crown. Flap gate in 6-inch by 6-inch concrete box located on the waterside (WS) end. Concrete headwall located on the landside (LS) toe. (18-inch pipe authorized under Automatic Board Order (ABO) issued as Permit No. 9572, 1974 - H. & A. Smith). [Additional Reference(s): DWR Levee Log, 1992. USACE Sacramento O&M Manual Unit 140, May 1960, (HLM 4.05)]. FS Date: 12/21/2016

Distribution box on WS toe with broken flap gate and 3-inch aluminum irrigation pipe.

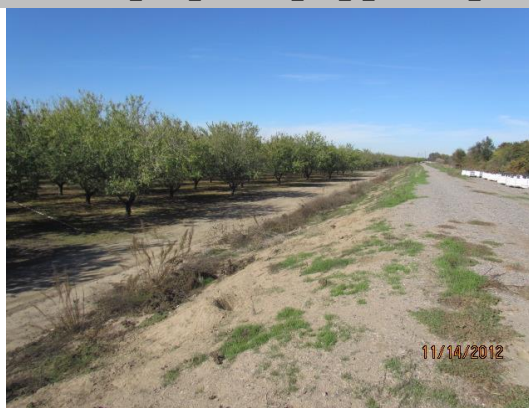
Photo 1 of 1 : SP_2017_LD0001G_432_7_20170315_00003.jpg

LM Start	5.08	Rating **	U	Issue No.	7
LM End	5.17	Issue Type +	Ma	Location *	LS
Category	Earthen Levee			GPS Latitude/Longitude	
				Start	End
Item	Animal Control			39.534741 °	39.536013 °
				-121.996024 °	-121.996702 °
DWR ID	DWR_LD0001G_01_f_2012_7				
Comment Code					
A3 : No rodents visible, but rodent burrows visible; need to backfill and compact or grout burrows.					
Inspector Comment

View of the rodent hole along the levee slope.

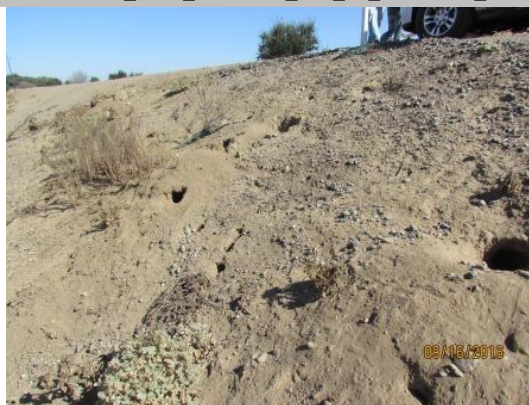
Photo 1 of 1 : SP_2017_LD0001G_432_67_20170315_00034.jpg

LM Start	5.22	Rating **	U	Issue No.	67
LM End	5.22	Issue Type +	Ma	Location *	LS
Category	Earthen Levee			GPS Latitude/Longitude	
				Start	End
Item	Animal Control			39.536750 °	39.536750 °
				-121.997090 °	-121.997090 °
DWR ID	DWR_LD0001G_01_s_2016_67				
Comment Code					
A1 : Exterminate rodents and backfill and compact or grout burrows.					
Inspector Comment					
Rodent holes on the LS slope need to be backfilled.

View of the rodent holes along the landside slope.

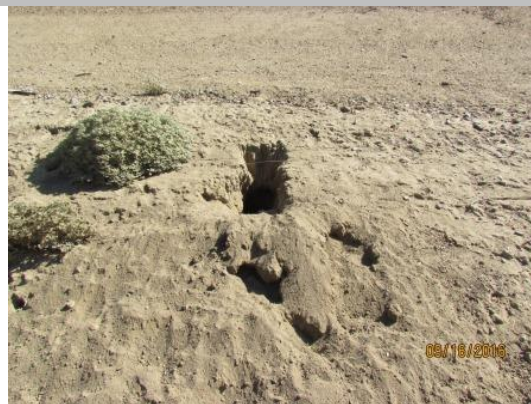
Photo 1 of 1 : SP_2017_LD0001G_432_75_20170315_00039.jpg

LM Start	5.55	Rating **	U	Issue No.	75
LM End	5.55	Issue Type +	Ma	Location *	LS
Category	Earthen Levee			GPS Latitude/Longitude	
				Start	End
Item	Animal Control			39.541110 °	39.541110 °
				-121.999348 °	-121.999348 °
DWR ID	DWR_LD0001G_01_f_2016_75				
Comment Code					
A1 : Exterminate rodents and backfill and compact or grout burrows.					
Inspector Comment					
Large rodent hole on the landside toe.

View of the rodent holes along the landside slope.

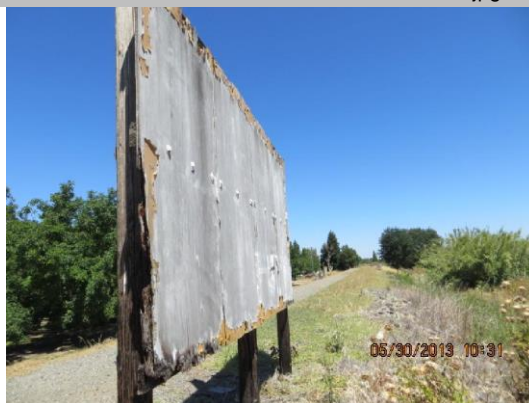
Photo 1 of 1 : UCIP_SP_2017_16224_27345.jpg

LM Start	6.18	Rating **	M	Issue No.	408
LM End	6.18	Issue Type +	En	Location *	LS
Category	Supplemental			GPS Latitude/Longitude	
				Start	End
Item	DWR UCIP Field Study			39.549938 °	39.549938 °
				-122.002110 °	-122.002110 °
DWR ID					
Comment Code					
Inspector Comment					
FS_ID:16224					
DS_ID:22937					
EP_NO: 5118					
Repair Type: Non-Urgent					
Crossing Status: Indicator Found					
UCIP Comments: Pipe needs new gasline markers as sign on WS shoulder is sunbleached and cannot be read.					
FIELD_STRUCT_DESC: 2 of 2: 12.75-inch high pressure gas line through levee 3.0 feet below crown (Permit No. 5118, 1965). Gasline sign on WS shoulder. [Additional Reference(s): DWR Levee Log, 1992].					
FS Date: 5/30/2013

Gasline sign on WS shoulder.

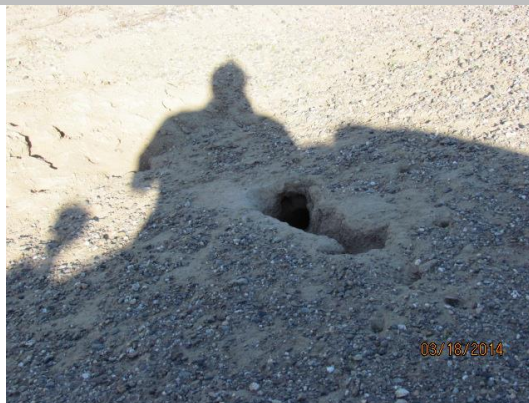
Photo 1 of 1 : SP_2017_LD0001G_432_47_20170315_00014.jpg

LM Start	6.22	Rating **	M	Issue No.	47
LM End	6.22	Issue Type +	Ma	Location *	LS
Category	Earthen Levee			GPS Latitude/Longitude	
				Start	End
Item	Animal Control			39.550533 °	39.550533 °
				-122.002319 °	-122.002319 °
DWR ID	DWR_LD0001G_01_s_2014_47				
Comment Code					
A3 : No rodents visible, but rodent burrows visible; need to backfill and compact or grout burrows.					
Inspector Comment

View of the rodent activity along the l/s slope.

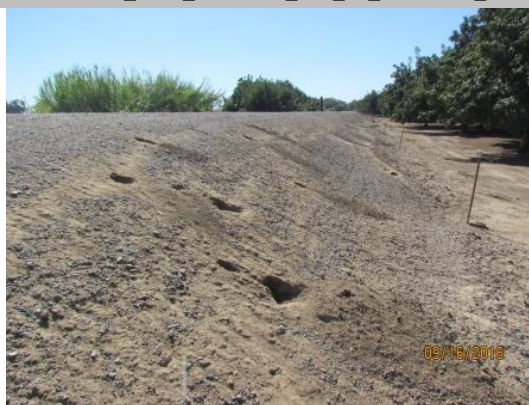
Photo 1 of 1 : SP_2017_LD0001G_432_76_20170315_00040.jpg

LM Start	6.24	Rating **	M	Issue No.	76
LM End	6.24	Issue Type +	Ma	Location *	LS
Category	Earthen Levee			GPS Latitude/Longitude	
				Start	End
Item	Animal Control			39.550725 °	39.550725 °
				-122.002370 °	-122.002370 °
DWR ID	DWR_LD0001G_01_f_2016_76				
Comment Code					
A3 : No rodents visible, but rodent burrows visible; need to backfill and compact or grout burrows.					
Inspector Comment

View of the rodent holes along the landside slope.

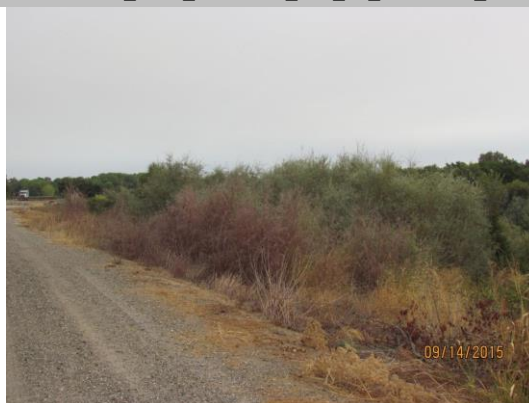
Photo 1 of 1 : SP_2017_LD0001G_432_65_20170315_00032.jpg

LM Start	6.30	Rating **	M	Issue No.	65
LM End	6.30	Issue Type +	Ma	Location *	WS
Category	Earthen Levee			GPS Latitude/Longitude	
				Start	End
Item	Vegetation			39.551665 °	39.551665 °
				-122.002639 °	-122.002639 °
DWR ID	DWR_LD0001G_01_f_2015_65				
Comment Code					
V2 : Remove the wild growth other than native grasses from the levee slopes.					
Inspector Comment					
Remove the vegetation from the waterside slope and toe.

View of the vegetation along the waterside slope and toe.

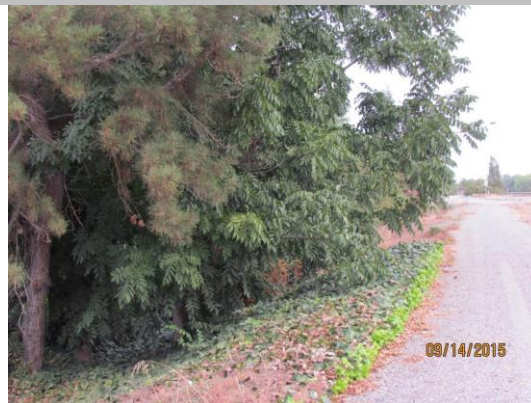
Photo 1 of 1 : SP_2017_LD0001G_432_64_20170315_00031.jpg

LM Start	6.30	Rating **	M	Issue No.	64
LM End	6.30	Issue Type +	Ma	Location *	LS
Category	Earthen Levee			GPS Latitude/Longitude	
				Start	End
Item	Trim / Thin Trees			39.551666 °	39.551666 °
				-122.002639 °	-122.002639 °
DWR ID	DWR_LD0001G_01_f_2015_64				
Comment Code					
T1 : Trim trees to at least five feet above ground level.					
Inspector Comment					
Trim trees along the landside slope.

View of the trees along the landside toe.

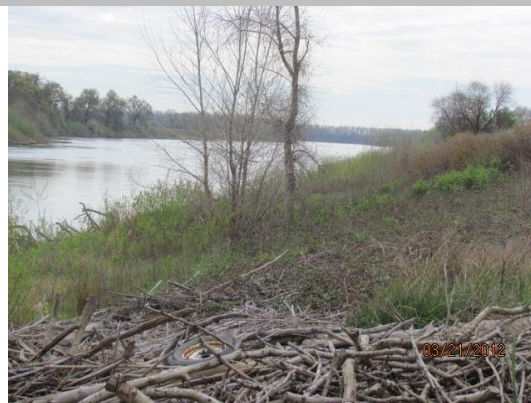
Photo 1 of 1 : SP_2017_LD0001G_432_10_20170315_00005.jpg

LM Start	6.38	Rating **	A/W	Issue No.	10
LM End	6.64	Issue Type +	Ma	Location *	WS
Category	Earthen Levee			GPS Latitude/Longitude	
				Start	End
Item	Vegetation			39.552691 °	39.556459 °
				-122.003063 °	-122.003831 °
DWR ID	DWR_LD0001G_01_s_2012_10				
Comment Code					
V8 : Environmental Requirements.					
Inspector Comment

View of the Army Corps of Engineers mitigation site.

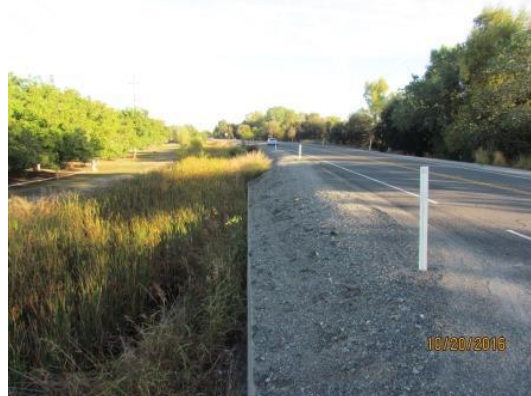
Photo 1 of 2 : SP_2017_LD0001G_432_69_20170315_00035.jpg

LM Start	6.65	Rating **	U	Issue No.	69
LM End	7.75	Issue Type +	En	Location *	LS
Category	Earthen Levee			GPS Latitude/Longitude	
				Start	End
Item	Encroachments			39.556556 °	39.572335 °
				-122.003868 °	-122.004690 °
DWR ID	DWR_LD0001G_01_s_2016_69				
Comment Code					
DT : Ditch					
Inspector Comment					
Concrete lined and earthen ditch/canal at LS toe.

Another view of the ag ditch looking upstream.

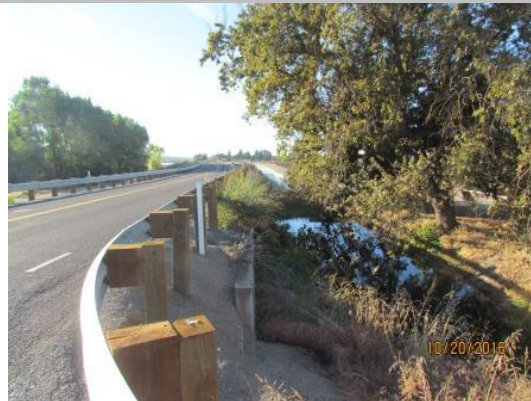
Photo 2 of 2 : SP_2017_LD0001G_432_69_20170315_00036.jpg

View of the ag ditch looking downstream.

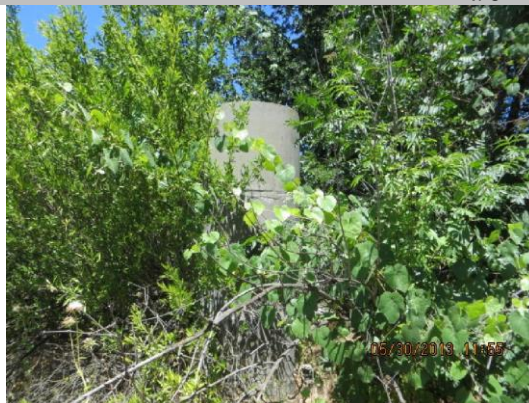
Photo 3 of 3 : UCIP_SP_2017_14384_23662.jpg

Item	DWR UCIP Field Study			39.560072 °		39.560072 °
				-122.005039 °		-122.005039 °
DWR ID						
Comment Code						
Inspector Comment						
FS_ID:14384 DS_ID:22917 EP_NO: 9702 Repair Type: Non-Urgent Crossing Status: Found UCIP Comments: Abandoned and should be done so properly. FIELD_STRUCT_DESC: 20-inch concrete encased steel irrigation pipe (not 24-inch pipe referenced in USACE manual) through levee, 7.2 feet below crown. Slant pump located on the waterside (WS) bank. Slide gate in 36-inch concrete standpipe on WS berm. (24-inch pipe authorized under Automatic Board Order (ABO) issued as Permit No. 9702, 1974 - J. & M. Bertapelle). [Additional Reference(s): DWR Levee Log, 1992. USACE Sacramento O&M Manual Unit 140, May 1960, (HLM 7.01)]. FS Date: 5/30/2013

Concrete standpipe off WS toe.

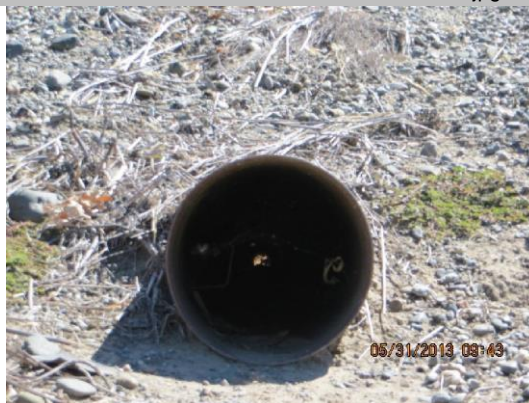
Photo 2 of 3 : UCIP_SP_2017_51285_23667.jpg

FS_ID:51285
DS_ID:22918
EP_NO: 9563
Repair Type: Urgent
Crossing Status: Found
UCIP Comments: 12/21/2016 same as last inspection crossing is opened on both ends and damaged on WS slope is visible. According to LMA representative, Nick Henning, pipe appears to be abandoned. (O. Magana - DWR UCIP)05/31/2013 Pipe open on both ends and damaged on WS slope. Pipe should be abandoned properly if appropriate. (W. Wylie - DWR UCIP)
FIELD_STRUCT_DESC: *ABANDONED* 12-inch steel drainage pipe through levee, 5 feet below crown. Pipe open on both waterside (WS) and landside (LS) ends. One corrugated metal cutoff wall. (12-inch pipe authorized under Automatic Board Order (ABO) No. 9563, 1974 - County of Glenn). [Additional Reference(s): DWR Levee Log, 1992. USACE Sacramento O&M Manual Unit 140, May 1960, (HLM 8.60)].
FS Date: 12/21/2016

Pipe on LS slope.

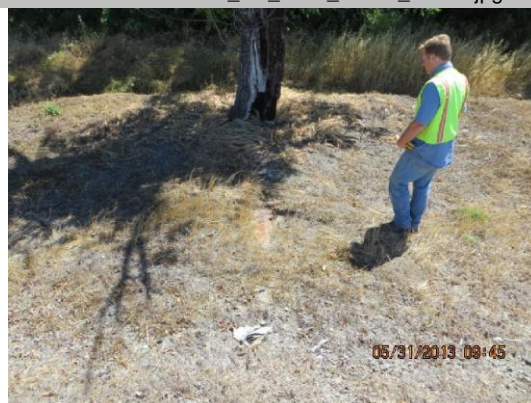
Photo 3 of 3 : UCIP_SP_2017_51285_23666.jpg

Item	DWR UCIP LMA Responsibility			39.582275 °	39.582275 °	
				-122.007449 °	-122.007449 °	
DWR ID						
Comment Code						
Inspector Comment						
FS_ID:51285 DS_ID:22918 EP_NO: 9563 Repair Type: Urgent Crossing Status: Found UCIP Comments: 12/21/2016 same as last inspection crossing is opened on both ends and damaged on WS slope is visible. According to LMA representative, Nick Henning, pipe appears to be abandoned. (O. Magana - DWR UCIP)05/31/2013 Pipe open on both ends and damaged on WS slope. Pipe should be abandoned properly if appropriate. (W. Wylie - DWR UCIP) FIELD_STRUCT_DESC: *ABANDONED* 12-inch steel drainage pipe through levee, 5 feet below crown. Pipe open on both waterside (WS) and landside (LS) ends. One corrugated metal cutoff wall. (12-inch pipe authorized under Automatic Board Order (ABO) No. 9563, 1974 - County of Glenn). [Additional Reference(s): DWR Levee Log, 1992. USACE Sacramento O&M Manual Unit 140, May 1960, (HLM 8.60)]. FS Date: 12/21/2016

Pipe on WS slope.

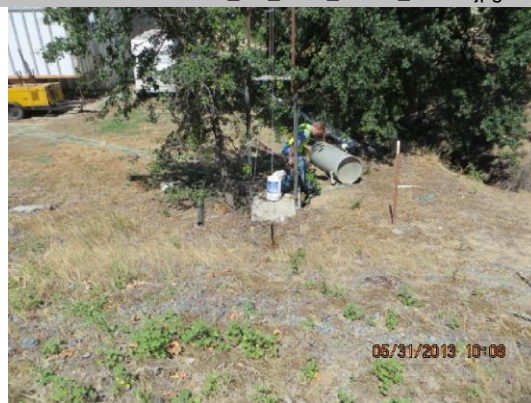
Photo 1 of 3 : UCIP_SP_2017_16204_27330.jpg

LM Start	8.83	Rating **	M	Issue No.	412
LM End	8.83	Issue Type +	En	Location *	WS
Category	Supplemental			GPS Latitude/Longitude	
				Start	End
Item	DWR UCIP Field Study			39.587028 °	39.587028 °
				-122.005609 °	-122.005609 °
DWR ID					
Comment Code					
Inspector Comment					
FS_ID:16204					
DS_ID:23147					
EP_NO: N/A					
Repair Type: Non-Urgent					
Crossing Status: Found					
UCIP Comments: Need to determine if this passes completely through levee and what Permit No. was issued for it.					
FIELD_STRUCT_DESC: 1.5-inch galvanized iron pipe through the levee 6-feet below the crown. 1-inch PVC irrigation line sleeved through this conduit.					
FS Date: 5/31/2013

Pipe visible next to well with bucket over standpipe.

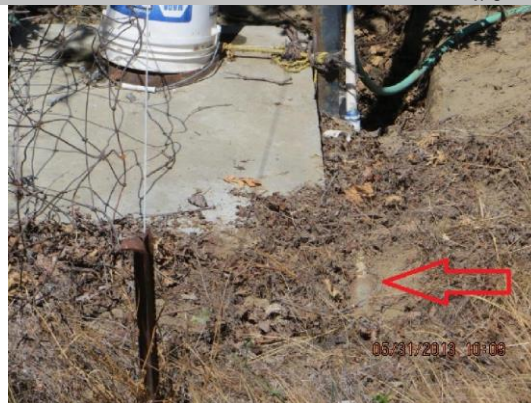
Photo 2 of 3 : UCIP_SP_2017_16204_27329.jpg

LM Start	8.83	Rating **	M	Issue No.	412 (cont)	
LM End	8.83	Issue Type +	En	Location *	WS	
Category	Supplemental			GPS Latitude/Longitude		
				Start	End	
Item	DWR UCIP Field Study			39.587028 °	39.587028 °	
				-122.005609 °	-122.005609 °	
DWR ID						
Comment Code						
Inspector Comment						
FS_ID:16204						
DS_ID:23147						
EP_NO: N/A						
Repair Type: Non-Urgent						
Crossing Status: Found						
UCIP Comments: Need to determine if this passes completely through						
levee and what Permit No. was issued for it.						
FIELD_STRUCT_DESC: 1.5-inch galvanized iron pipe through the						
levee 6-feet below the crown. 1-inch PVC irrigation line sleeved						
through this conduit.						
FS Date: 5/31/2013

Pipe visible next to well with bucket over standpipe.

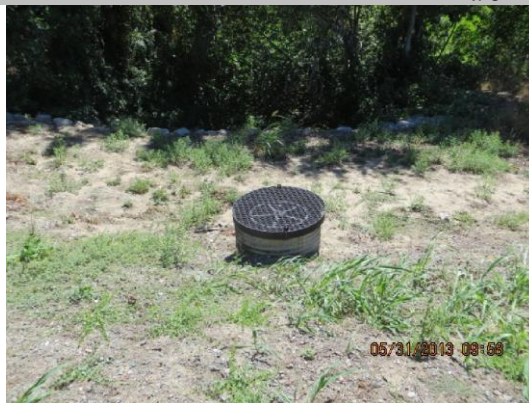
Photo 3 of 3 : UCIP_SP_2017_16226_27354.jpg

Comment Code					
Inspector Comment					
FS_ID:16226 DS_ID:22919 EP_NO: 9562 Repair Type: No Action Needed Crossing Status: Found UCIP Comments: FIELD_STRUCT_DESC: 24-inch drainage pipe with 3/8-inch wall epoxy coated steel sleeved through existing 30-inch corrugated metal pipe through the levee, 15 feet below the crown. Flap gate located on the waterside (WS) end. Slide gate in 44-inch corrugated metal pipe (CMP) riser on WS slope. Concrete headwalls on both ends. Two corrugated metal cutoff walls. (24-inch pipe was authorized under Permit No. 9562-1, 2011 - Levee District No. 1 - Glenn County; original 30-inch pipe was authorized under Automatic Board Order (ABO) issued as Permit No. 9562, 1974 - L. R. Henrich). [Additional Reference(s): DWR Levee Log, 1992. USACE Sacramento O&M Manual Unit 140, May 1960, (HLM 8.98)]. FS Date: 5/31/2013

Slide gate in 44-inch CMP riser on WS slope.

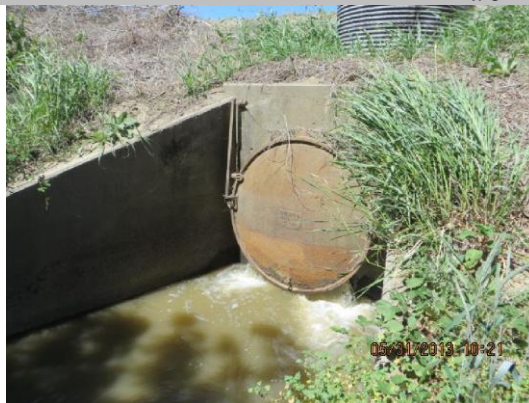
Photo 3 of 3 : UCIP_SP_2017_14389_23684.jpg

Comment Code					
Inspector Comment					
FS_ID:14389 DS_ID:22920 EP_NO: 9560 Repair Type: Non-Urgent Crossing Status: Found UCIP Comments: Heavy rust along springline of pipe. Pipe has slight deformation at centerline of levee, not noticable on crown. FIELD_STRUCT_DESC: 72-inch corrugated metal drainage pipe through levee, 15 feet below crown. Flap gate located on the waterside (WS) end. Slide gate in 8-inch corrugated metal pipe (CMP) riser on WS slope. Concrete headwalls on both ends. Two corrugated metal cutoff walls. (72-inch pipe authorized under Automatic Board Order (ABO) issued under Permit No. 9560, 1974 - J. & L. Friesen). [Additional Reference(s): DWR Levee Log, 1992. USACE Sacramento O&M Manual Unit 140, May 1960, (HLM 9.64)]. FS Date: 5/31/2013

Flap gate and headwall on WS toe.

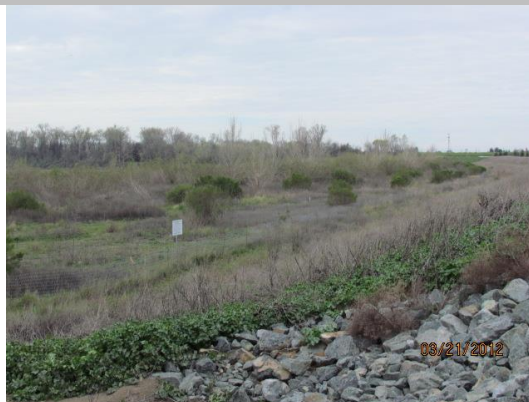
Photo 1 of 1 : SP_2017_LD0001G_432_8_20170315_00004.jpg

LM Start	9.50	Rating **	A/W	Issue No.	8
LM End	10.40	Issue Type +	Ma	Location *	WS
Category	Earthen Levee			GPS Latitude/Longitude	
				Start	End
Item	Vegetation			39.596192 °	39.607288 °
				-122.002573 °	-121.994565 °
DWR ID	DWR_LD0001G_01_s_2012_8				
Comment Code					
V8 : Environmental Requirements.					
Inspector Comment

View of the Army Corps of Engineers mitigation site.

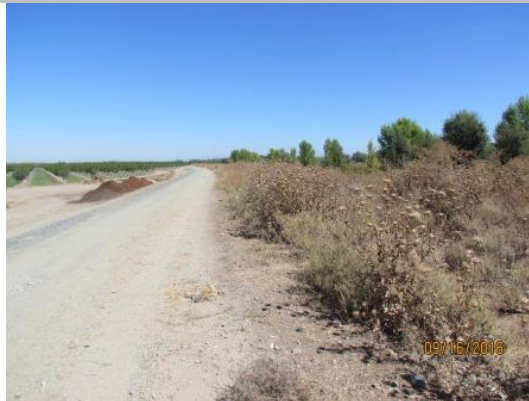
Photo 1 of 1 : SP_2017_LD0001G_432_78_20170315_00041.jpg

LM Start	9.51	Rating **	M	Issue No.	78
LM End	9.91	Issue Type +	Ma	Location *	WS
Category	Earthen Levee			GPS Latitude/Longitude	
				Start	End
Item	Vegetation			39.596270 °	39.601582 °
				-122.002523 °	-121.999487 °
DWR ID	DWR_LD0001G_01_f_2016_78				
Comment Code					
V1 : Control annual grass and weeds on the levee slopes and easements.					
Inspector Comment

View of the waterside vegetation looking upstream.

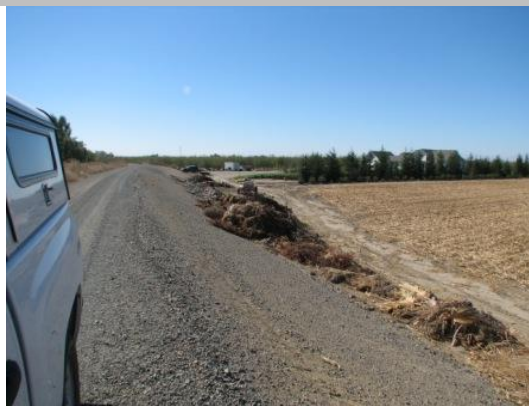
Photo 1 of 1 : SP_2017_LD0001G_432_11_20170315_00006.jpg

LM Start	9.54	Rating **	M	Issue No.	11
LM End	9.64	Issue Type +	En	Location *	LS
Category	Earthen Levee			GPS Latitude/Longitude	
				Start	End
Item	Encroachments			39.596705 °	39.598066 °
				-122.002247 °	-122.001704 °
DWR ID	DWR_LD0001G_01_s_2012_11				
Comment Code					
DE : Debris					
Inspector Comment					
Landscaping materials: mulch, wood chips, rock baskets, stacks of pavestones

View of debris along the toe of the levee.

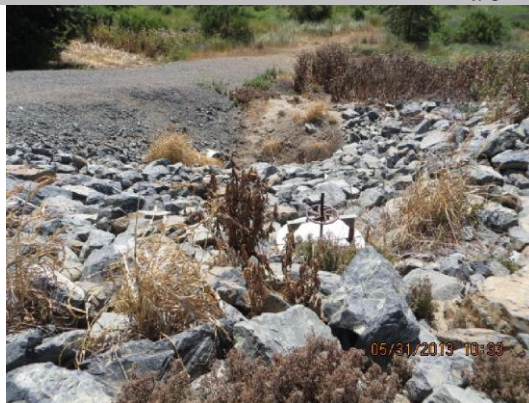
Photo 1 of 3 : UCIP_SP_2017_14390_23690.jpg

Comment Code					
Inspector Comment					
FS_ID:14390					
DS_ID:22921					
EP_NO: 9559					
Repair Type: No Action Needed					
Crossing Status: Found					
UCIP Comments:					
FIELD_STRUCT_DESC: 24-inch corrugated metal drainage pipe through levee, 11 feet below crown. Flap gate is located on the waterside (WS) end. Slide gate in 36-inch corrugated metal pipe riser on WS slope. Concrete headwalls on both ends. Two corrugated metal cutoff walls. (24-inch pipe authorized under Automatic Board Order (ABO) issued as Permit No. 9559, 1974 - D. & M. Giesbrecht). [Additional Reference(s): DWR Levee Log, 1992. USACE Sacramento O&M Manual Unit 140, May 1960, (HLM 10.05)].					
FS Date: 5/31/2013

Slide gate in 36-inch CMP riser on WS slope.

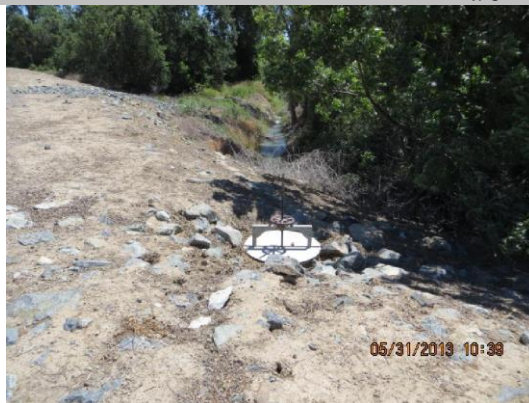
Photo 2 of 3 : UCIP_SP_2017_14559_23985.jpg

Item	DWR UCIP LMA Responsibility			39.601659 °		39.601659 °
				-121.999209 °		-121.999209 °
DWR ID						
Comment Code						
Inspector Comment						
FS_ID:14559 DS_ID:22922 EP_NO: 9558 Repair Type: No Action Needed Crossing Status: Found UCIP Comments: FIELD_STRUCT_DESC: 24-inch corrugated metal drainage pipe through levee, 11 feet below crown. Flap gate is located on waterside (WS) end. Slide gate in 36-inch corrugated metal pipe riser on WS slope. Two corrugated metal cutoff walls. Concrete headwalls on both ends. (24-inch pipe authorized under Automatic Board Order (ABO) issued as Permit No. 9558, 1974 - D. Geis). Originally included in the 1960 O&M manual. [Additional Reference(s): DWR Levee Log, 1992. USACE Sacramento O&M Manual Unit 140, May 1960, (HLM 10.08)]. FS Date: 5/31/2013 8:43:01 AM

Slide gate in 36-inch CMP riser on WS slope.

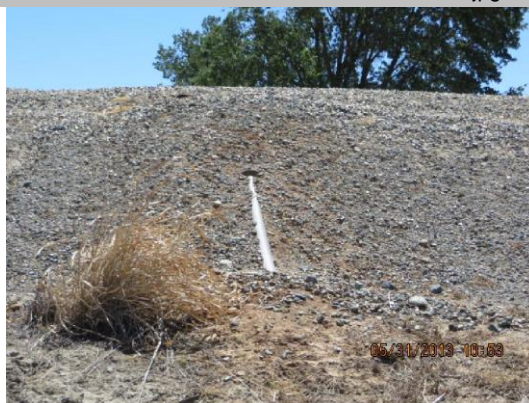
Photo 2 of 3 : UCIP_SP_2017_16205_27332.jpg

LM Start	10.20	Rating **	M	Issue No.	417
LM End	10.20	Issue Type +	En	Location *	LS
Category	Supplemental			GPS Latitude/Longitude	
				Start	End
Item	DWR UCIP Field Study			39.604696 °	39.604696 °
				-121.996265 °	-121.996265 °
DWR ID					
Comment Code					
Inspector Comment					
FS_ID:16205					
DS_ID:23148					
EP_NO: N/A					
Repair Type: Non-Urgent					
Crossing Status: Found					
UCIP Comments: Need to determine Permit No. for crossing.					
FIELD_STRUCT_DESC: 6-inch steel conduit through the levee 8-inches below the crown. Pump, vent, filter, and siphon breaker on LS toe. 4-inch PVC irrigation line sleeved through conduit for vegetation rehabilitation on WS slope.					
FS Date: 5/31/2013

Pipe on LS slope.

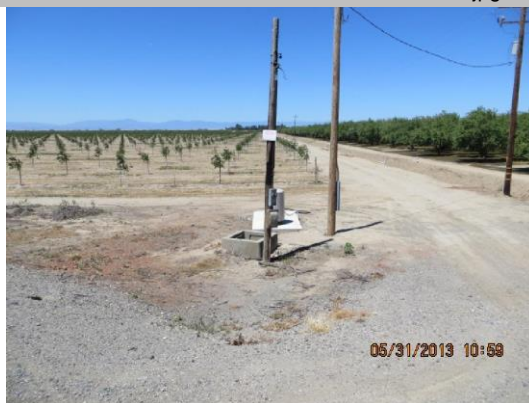
Photo 1 of 3 : UCIP_SP_2017_14561_23989.jpg

Comment Code					
Inspector Comment					
FS_ID:14561 DS_ID:22923 EP_NO: 9557 Repair Type: Non-Urgent Crossing Status: Found UCIP Comments: This pipe appears abandoned and should be done so properly. FIELD_STRUCT_DESC: 1 of 2: 10-inch irrigation pipe of unknown material through levee, 3.7 feet below crown. Pump on bank. Siphon breaker on waterside (WS) berm. One corrugated metal cutoff wall. Concrete distribution box at toe of landside (LS) slope (10-inch pipe authorized under Automatic Board Order (ABO) issued as Permit No. 9557, 1974 - R. & R. Weis). [Additional Reference(s): DWR Levee Log, 1992. USACE Sacramento O&M Manual Unit 140, May 1960, (HLM 10.56)]. FS Date: 5/31/2013

Concrete distribution box at LS toe.

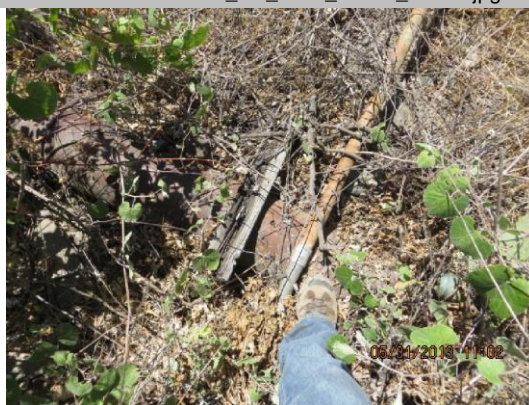
Photo 3 of 3 : UCIP_SP_2017_14561_23987.jpg

Item	DWR UCIP Field Study			39.607474 °		39.607474 °
				-121.994410 °		-121.994410 °
DWR ID						
Comment Code						
Inspector Comment						
FS_ID:14561 DS_ID:22923 EP_NO: 9557 Repair Type: Non-Urgent Crossing Status: Found UCIP Comments: This pipe appears abandoned and should be done so properly. FIELD_STRUCT_DESC: 1 of 2: 10-inch irrigation pipe of unknown material through levee, 3.7 feet below crown. Pump on bank. Siphon breaker on waterside (WS) berm. One corrugated metal cutoff wall. Concrete distribution box at toe of landside (LS) slope (10-inch pipe authorized under Automatic Board Order (ABO) issued as Permit No. 9557, 1974 - R. & R. Weis). [Additional Reference(s): DWR Levee Log, 1992. USACE Sacramento O&M Manual Unit 140, May 1960, (HLM 10.56)]. FS Date: 5/31/2013

10-inch steel pipe and 1.5-inch electrical conduit on WS slope.

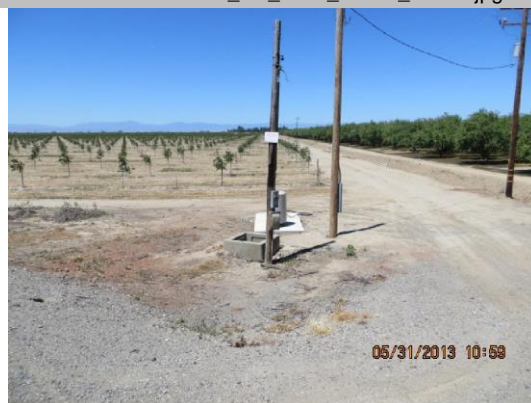
Photo 1 of 2 : UCIP_SP_2017_14562_23991.jpg

LM Start	10.41	Rating **	M	Issue No.	419
LM End	10.41	Issue Type +	En	Location *	LS
Category	Supplemental			GPS Latitude/Longitude	
				Start	End
Item	DWR UCIP Field Study			39.607474 °	39.607474 °
				-121.994410 °	-121.994410 °
DWR ID					
Comment Code					
Inspector Comment					
FS_ID:14562					
DS_ID:22938					
EP_NO: 9557					
Repair Type: Non-Urgent					
Crossing Status: Found					
UCIP Comments: Abandoned and should be done so properly.					
FIELD_STRUCT_DESC: 2 of 2: 1.5 inch galvanized iron electrical					
conduit through the levee 3.0 feet below the crown (ABO No. 9557,					
1974). Originally included in the 1960 O&M manual. [Additional					
Reference(s): DWR Levee Log, 1992. USACE Sacramento O&M					
Manual Unit 140, May 1960, (Station XX+XX)].					
FS Date: 5/31/2013

Source at JP next to concrete distribution box at LS toe.

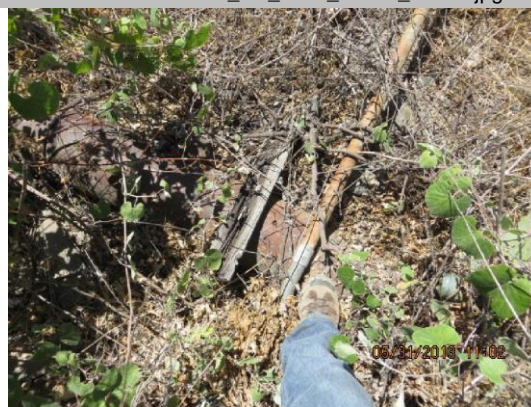
Photo 2 of 2 : UCIP_SP_2017_14562_23990.jpg

Pipe visible off WS toe.

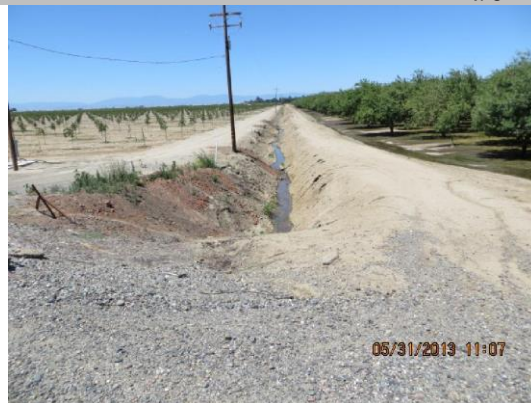
Photo 1 of 3 : UCIP_SP_2017_51286_24006.jpg

UCIP Comments: 12/21/2016 same as last inspection flap gate disabled in open position. Surface erosion observed on LS slope. Recommend repair on WS flap gate to be able to close flap gate. (O. Magana - DWR UCIP)05/31/2013 Flap gate dissabled in open position. Pipe rusted through at WS toe upstream of Flapgate. (W. Wylie - DWR UCIP)

Drainage channel on LS toe.

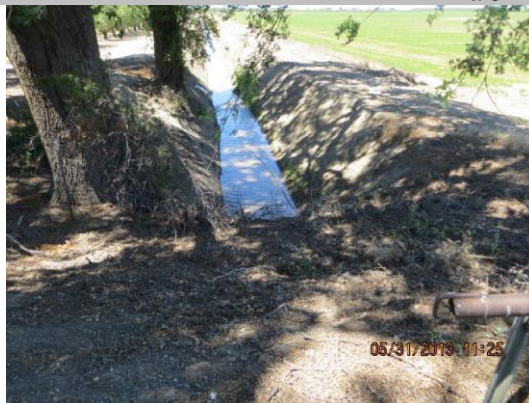
Photo 1 of 3 : UCIP_SP_2017_14565_24009.jpg

LM Start	11.02	Rating **	A/W	Issue No.	421
LM End	11.02	Issue Type +	Ma	Location *	LS
Category	Supplemental			GPS Latitude/Longitude	
				Start	End
Item	DWR UCIP LMA Responsibility			39.616041 °	39.616041 °
				-121.994450 °	-121.994450 °
DWR ID					
Comment Code					
Inspector Comment					
FS_ID:14565 DS_ID:22925 EP_NO: 9556 Repair Type: No Action Needed Crossing Status: Found UCIP Comments: FIELD_STRUCT_DESC: 48-inch corrugated metal drainage pipe of unknown material through levee, 11 feet below crown. Flap gate on waterside (Ws) end. Concrete headwall on both ends. Slide gate in 60-inch diameter corrugated metal pipe (CMP) riser on WS slope (48-inch authorized under Automatic Board Order (ABO) issued under Permit No. 9556, 1974 - E. R. & M. R. Cooper). [Additional Reference(s): DWR Levee Log, 1992. USACE Sacramento O&M Manual Unit 140, May 1960, (HLM 11.17)]. FS Date: 5/31/2013

Drainage ditch on LS toe.

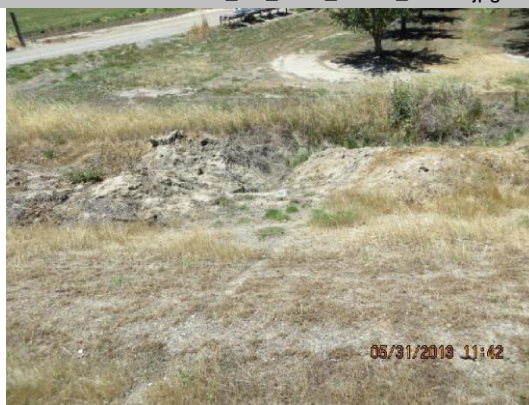
Photo 1 of 3 : UCIP_SP_2017_14566_24013.jpg

LM Start	11.64	Rating **	A/W	Issue No.	422
LM End	11.64	Issue Type +	Ma	Location *	WS
Category	Supplemental			GPS Latitude/Longitude	
				Start	End
Item	DWR UCIP LMA Responsibility			39.623874 °	39.623874 °
				-121.999813 °	-121.999813 °
DWR ID					
Comment Code					
Inspector Comment					
FS_ID:14566 DS_ID:22926 EP_NO: 9555 Repair Type: No Action Needed Crossing Status: Found UCIP Comments: FIELD_STRUCT_DESC: 24-inch corrugated metal drainage pipe through levee, 8.5 feet below crown. Flap gate on waterside (WS) slope. U-shaped concrete headwalls on both ends. Two corrugated metal cutoff walls. (24-inch pipe authorized under Automatic Board Order (ABO) issued as Permit No. 9555, 1974 - F. S. Reager). [Additional Reference(s): DWR Levee Log, 1992. USACE Sacramento O&M Manual Unit 140, May 1960, (HLM 11.81)]. FS Date: 5/31/2013

Concrete headwall on LS toe.

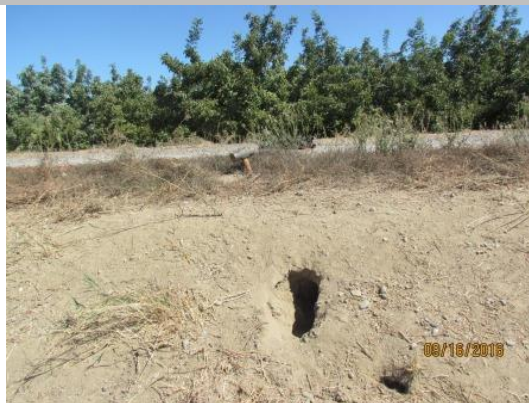
Photo 1 of 2 : SP_2017_LD0001G_432_79_20170315_00042.jpg

LM Start	11.66	Rating **	U	Issue No.	79
LM End	11.66	Issue Type +	Ma	Location *	LS
Category	Earthen Levee			GPS Latitude/Longitude	
				Start	End
Item	Animal Control			39.624112 °	39.624112 °
				-121.999933 °	-121.999933 °
DWR ID	DWR_LD0001G_01_f_2016_79				
Comment Code					
A1 : Exterminate rodents and backfill and compact or grout burrows.					
Inspector Comment					
Rodent holes on the landside slope and crown.

View of the rodent holes along the landside slope with large hammer sitting in the hole.

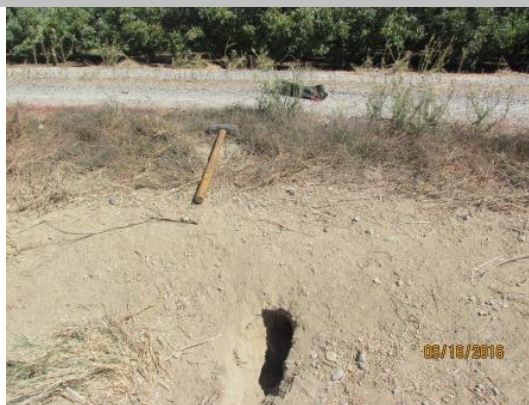
Photo 2 of 2 : SP_2017_LD0001G_432_79_20170315_00043.jpg

Another view of the rodent holes along the landside slope with a large hammer sitting next to the hole.

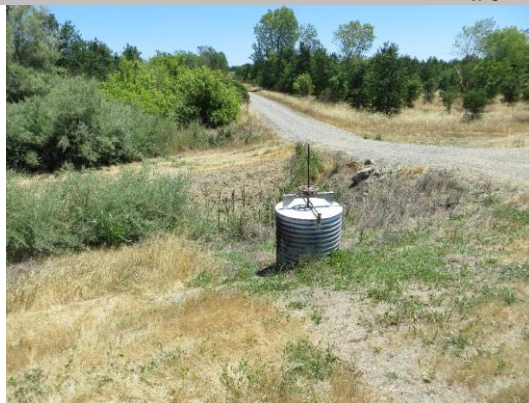
Photo 1 of 3 : UCIP_SP_2017_14569_24026.jpg

Comment Code					
Inspector Comment					
FS_ID:14569 DS_ID:22928 EP_NO: 9554 Repair Type: Non-Urgent Crossing Status: Found UCIP Comments: Flap gate heavily corroded. Good candidate for video inspection. Vegetation interfering with inlet. FIELD_STRUCT_DESC: 24-inch corrugated metal drainage pipe through levee, 7 feet below crown. Flap gate on waterside (WS) end. Slide gate in 36-inch corrugated metal pipe riser on WS slope. Concrete headwalls on both ends. Two corrugated metal cutoff walls. (24-inch pipe authorized under Automatic Board Order (ABO) issued as Permit No. 9554, 1974 - T. H. Reed). [Additional Reference(s): DWR Levee Log, 1992. USACE Sacramento O&M Manual Unit 140, May 1960, (HLM 12.04)]. FS Date: 5/31/2013

Slidegate in 36-inch CMP riser on WS slope.

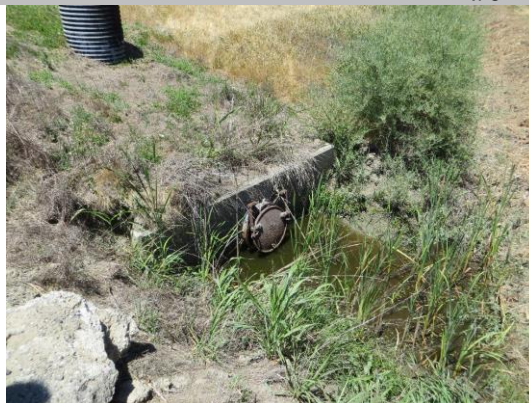
Photo 3 of 3 : UCIP_SP_2017_14569_24024.jpg

Item	DWR UCIP LMA Responsibility			39.626918 °	39.626918 °	
				-122.001421 °	-122.001421 °	
DWR ID						
Comment Code						
Inspector Comment						
FS_ID:14569						
DS_ID:22928						
EP_NO: 9554						
Repair Type: Non-Urgent						
Crossing Status: Found						
UCIP Comments: Flap gate heavily corroded. Good candidate for video inspection. Vegetation interfering with inlet.						
FIELD_STRUCT_DESC: 24-inch corrugated metal drainage pipe through levee, 7 feet below crown. Flap gate on waterside (WS) end. Slide gate in 36-inch corrugated metal pipe riser on WS slope. Concrete headwalls on both ends. Two corrugated metal cutoff walls. (24-inch pipe authorized under Automatic Board Order (ABO) issued as Permit No. 9554, 1974 - T. H. Reed). [Additional Reference(s): DWR Levee Log, 1992. USACE Sacramento O&M Manual Unit 140, May 1960, (HLM 12.04)].						
FS Date: 5/31/2013

Headwall and flapgate on WS toe.

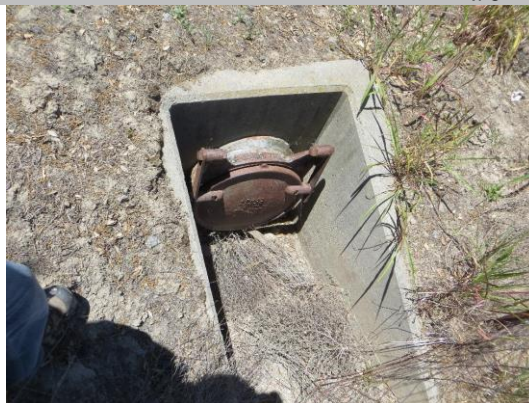
Photo 1 of 3 : UCIP_SP_2017_14570_24029.jpg

LM Start	12.13	Rating **	A/W	Issue No.	425
LM End	12.13	Issue Type +	Ma	Location *	LS
Category	Supplemental			GPS Latitude/Longitude	
				Start	End
Item	DWR UCIP LMA Responsibility			39.630451 °	39.630451 °
				-122.002737 °	-122.002737 °
DWR ID					
Comment Code					
Inspector Comment					
FS_ID:14570 DS_ID:22929 EP_NO: 9554 Repair Type: No Action Needed Crossing Status: Found UCIP Comments: FIELD_STRUCT_DESC: 24-inch corrugated metal drainage pipe through levee, 7 feet below crown. Flap gate on waterside (WS) end. Slide gate in 36-inch corrugated metal pipe (CMP) riser on WS slope. U-shaped concrete headwalls on both ends. (24-inch pipe authorized under Automatic Board Order (ABO) issued under Permit No. 9554, 1974 - T. H. Reed). [Additional Reference(s): DWR Levee Log, 1992. USACE Sacramento O&M Manual Unit 140, May 1960, (HLM 12.29)]. FS Date: 5/31/2013

Flapgate and U-shaped concrete headwall on WS toe.

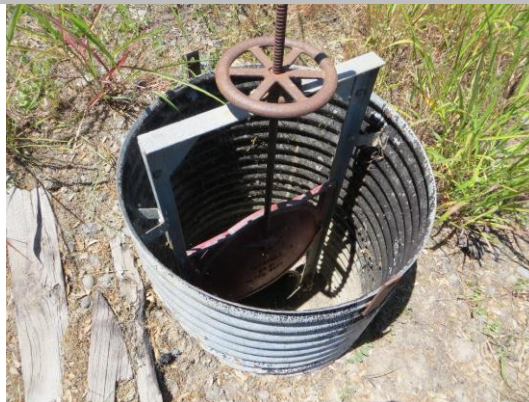
Photo 2 of 3 : UCIP_SP_2017_14570_24028.jpg

Slidegate in 36-inch CMP riser on WS slope.

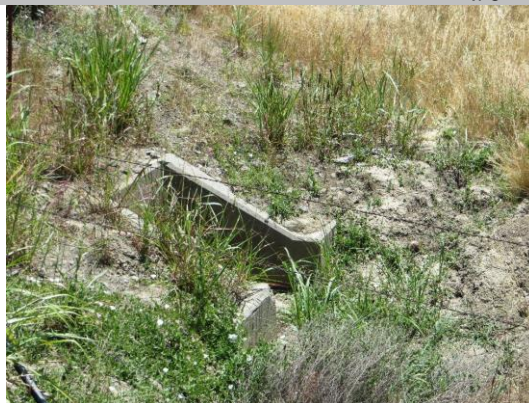
Photo 3 of 3 : UCIP_SP_2017_14570_24027.jpg

LM Start	12.13	Rating **	A/W	Issue No.	425 (cont)
LM End	12.13	Issue Type +	Ma	Location *	LS
Category	Supplemental			GPS Latitude/Longitude	
				Start	End
Item	DWR UCIP LMA Responsibility			39.630451 °	39.630451 °
				-122.002737 °	-122.002737 °
DWR ID					
Comment Code					
Inspector Comment					
FS_ID:14570 DS_ID:22929 EP_NO: 9554 Repair Type: No Action Needed Crossing Status: Found UCIP Comments: FIELD_STRUCT_DESC: 24-inch corrugated metal drainage pipe through levee, 7 feet below crown. Flap gate on waterside (WS) end. Slide gate in 36-inch corrugated metal pipe (CMP) riser on WS slope. U-shaped concrete headwalls on both ends. (24-inch pipe authorized under Automatic Board Order (ABO) issued under Permit No. 9554, 1974 - T. H. Reed). [Additional Reference(s): DWR Levee Log, 1992. USACE Sacramento O&M Manual Unit 140, May 1960, (HLM 12.29)]. FS Date: 5/31/2013

U-shaped concrete headwall on LS toe.
